Harpham & Lowthorpe Village Hall

Asbestos Register & Control Policy

Stephen Harrison
January 2021

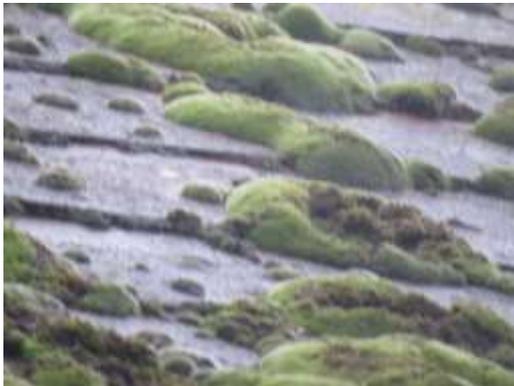
Photo 1

The asbestos cement tile coverings were generally found to be in fair condition although supporting a large degree of moss growth across the provision (see photo 1). To the rear catslide element in particular the change in gradient, a number of tiles are displaced, with repair evident (see photo 2).
