Building Survey

Village Hall,
Station Road,
Harpham
East Riding of Yorkshire
YO25 4QZ

DMP/CS641/December 2020

Client – The Committee, Harpham Village Hall

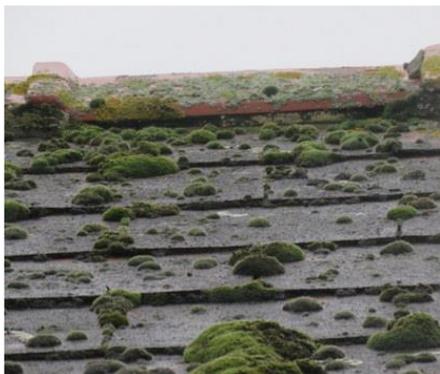
In addition, the mortar detail to the ridge tiles was found to be cracked and missing in isolated areas across the provision. Due to the levels of moss evident it could not be ascertained to the condition of the mortar to other areas. The defective areas will require cutting out/repointing to maintain the water tightness/integrity of the detail.

The tiles along the top of the roof (the ridge tiles) are covered with angled clay profiled ridge tiles of a contrasting colour to the main coverings. The mortar pointing to the ridge tiles was found to be in fair condition although open/cracked/missing in isolated areas and should be repointed to maintain a watertight roof structure. Inspection of the provision was found to be restrictive due to the levels of moss growth evident to the mortar detail (each side of the ridge)

Open mortar joints are evident to the ridge tiles in a number of locations along the length of the provision.

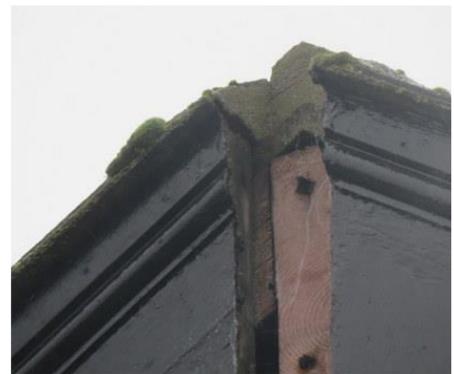
The bargeboard detail to the gable ends of the building were found to be constructed of painted two piece section of softwood timber mitred at the joint with the ridge (a softwood moulding is present to the edge of the provision). The timber has been finished with a paint application which is in a fair condition. However minor levels of timber decay were found to be evident with joinery repairs required (especially to the front/rear gable elements were replacement of the missing finials are required). Any replacement timber boarding should be tanalised treated with a section to match, prior to redecoration being undertaken.

Apex timber to the bargeboards has decayed/is missing.

Joinery repairs were found to be required to the external softwood timber fascia/barge board present (especially the finials details which were missing above the gable elements) in a number of areas due to the levels of decay evident to the provision. All replacement timber should be tanalised treated in order to prevent decay occurring the provision. A good quality paint system should be utilised i.e. Dulux Weathershield in order to ensure that the life of the timber is extended.

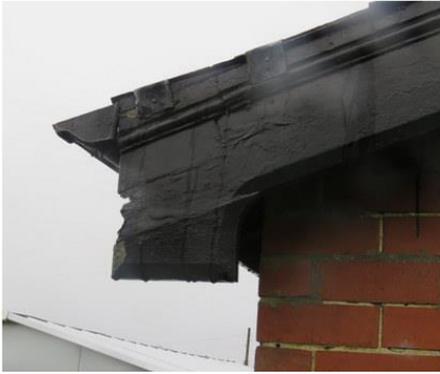
The verge detail at the junction of the gable external walls and the edge of the pitched roof coverings were found to be formed/completed with a painted softwood timber moulding fixed to the face of the bargeboard present. The detail was found to be in fair condition although minor decay of the timber was evident.

Decay is evident to the timber fascia's/bargeboards in isolated areas.

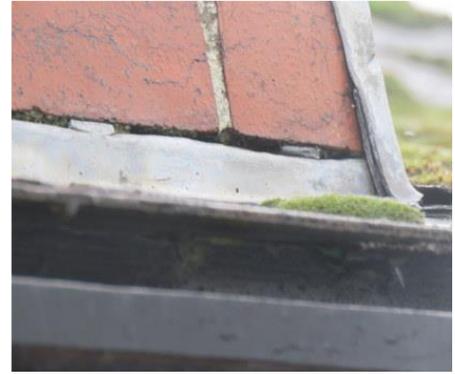
To the rear of the main roof area the chimney stack present appears to be terminated with a pre-cast concrete capping (once supporting the fireplace evident in the female cloakroom area). The mortar joints to the brickwork to the chimney stack were found to be open to areas securing the lead stepped flashing detail. An isolated area of lead flashing is displaced/missing and requires reinstating to maintain the weather tightness of the roof area/detail. P

Open/missing mortar is evident to the brick built chimney stack in isolated areas.

To the rear elevation of the building, the original chimney (to the fireplace present within female cloakroom area) has been reduced in height and capped off with a precast concrete capping. The lead flashings to the sheet provisions are still evident. However, sections are displaced/an element missing with the mortar joints securing the provision open. The flashing detail requires chasing into the mortar joint of the brickwork to a depth of 25mm and then re-pointed with a suitable lime mortar to form a watertight joint.

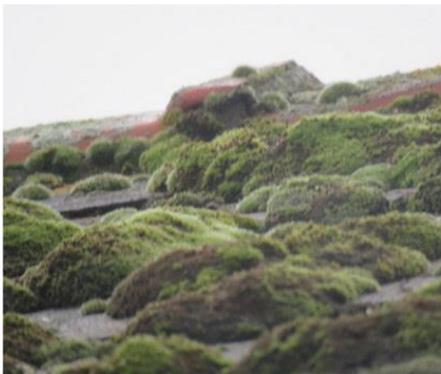
The asbestos cement tiles were found to be heavily covered with a moss growth across the provision. During storm conditions these will become detached and litter the gutters present. Issues will become evident if the face of the tiles becomes detached and enters the drainage system, releasing fibres.

The asbestos cement tile coverings were generally found to be in fair condition although supporting a large degree of moss growth across the provision. To the rear catslide element in particular the change in gradient, a number of tiles are displaced, with repair evident.

Moss build-up is evident to the possible asbestos containing roof tiles in isolated areas.

Replacement of the coverings should be considered due to the age and life expectancy of the provision. A number of light weight coverings are available of the market that would be suitable for replacement. It is believed that no sarking membrane will be present under the tiles (as these are believed to be the original roof coverings) and will be required under any new coverings (the existing is believed to be laid over timber close boarding. Further advice/guidance to maintaining the provision is provided on the HSE's website for further assistance.

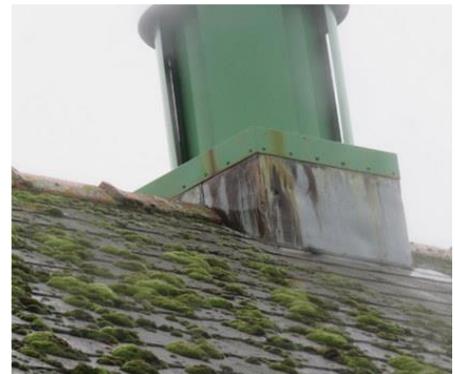
The main roof area of the building is provided with a circular steel ornate cupola vent located on a raised plinth above the centre of the ridge. A lead upstand and associated flashing detail is provided to form a watertight joint with the roof provision. The steel cupola is finished with a decorative paint application which is degraded/flaking with surface corrosion present. The lead sheet provision to the upstand detail is soiled due to the lack of an adequate drip detail from the steel cupola provision, although performing as intended. The fixings/cover caps securing the cupola were found to be present across the upstand detail.

Corrosion staining/impact damage is evident to the cupola vent in areas.

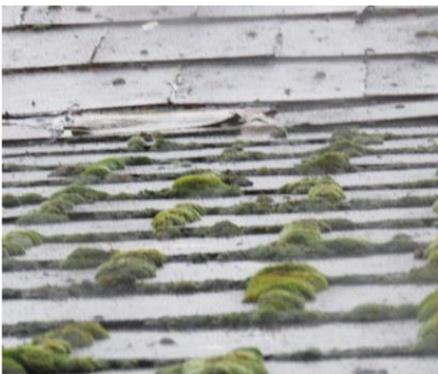
A small number of tiles present to the catslide element (at the change of gradient) were found to be displaced (possibly following repair) and require reinstatement (to prevent potential loss during storm conditions). Care should be taken when accessing the roof to prevent damage to adjacent coverings.

Previous patch repair is evident to the roof tiles in an isolated location.

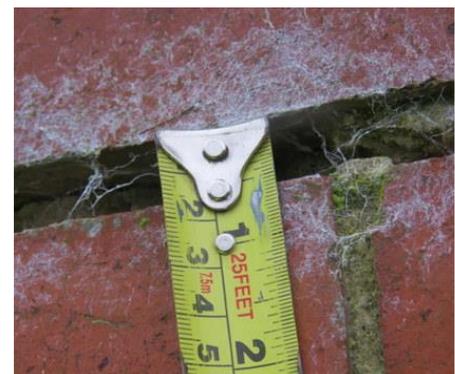
- b) The external brickwork to the building was generally found to be in fair condition although areas of open/cracked mortar was found to be evident (especially to the rear gable provision) in a distinct pattern, horizontally at approximately 340mm centres (4No courses) in locations across the wall area. The open mortar joints were found to have expanded from 10mm to 15mm in the locations of the cracking. Internally hairline cracking was evident (with loose areas of finish) to the plaster finishes.

Originally cavity wall ties were made to brace the inner and outer leaves of their walls, using iron or mild steel to ensure their stability, however, under damp conditions, iron or steel corrode. To prevent them from deteriorating, wall ties were coated in bitumen or zinc galvanised with a protective finish. However, over time, it is not uncommon for wall ties to corrode as a result of the protective coating breaking down. This is especially evident were the displacement of the mortar from the cracking allows increased levels of moisture/rainwater into the cavity (due to the expansion of the metal applying further pressure and cracking to occur).

The design of cavity walls makes them relatively unstable and they depend upon the wall ties present. Walls of cavity construction should incorporate ties to hold together the inner and outer leaves of masonry. As there is no access to the cavity, it has not been inspected and we cannot comment on the presence/or condition of wall ties. However, to the end gable of the property cracking within the bed joints of the brickwork at approximately 340mm centres (4 courses) in isolated areas in particular to the left hand section of the wall, which may indicate corrosion of the tiles has occurred. Further intrusive investigation is therefore required to determine the extent of the issue.

Open/failed mortar as a result of possible cavity wall tie failure is evident in isolated locations.

Further intrusive investigation of the issue is required to the area by a competent contractor specialised in such work. Investigation is usually undertaken by locating the ties using a metal detector and then either removing a brick or the mortar or drilling a small hole and inserting an endoscope (a TV camera on a flexible probe) into the cavity to examine their condition. The replacement ties will be selected to suit the substrate evident in line with the Building Digest 401 guidelines. A guarantee is provided for the remediation work undertaken.

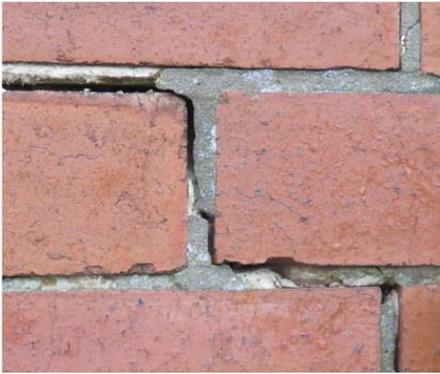
Due to the length of the uninterrupted lengths of masonry thermal movement of the brickwork has occurred in the gable wall in the form of stepped cracking (1 -2mm following the mortar joint in a stepped manner at low level (a number of courses above the damp proof course level). The co-efficient of expansion due to thermal/wetting of the brickwork occurs 1mm in every 1.00m length. Remedial work is again required to maintain the integrity against rainwater entry into the cavity evident. The cracking and eroded mortar apparent requires replacement with a lime mortar instead of the sand/cement mix present. The mortar requires removal to a depth of 25mm to ensure that enough new material is applied. Ideally an expansion joint should be formed within the elevation to allow expansion to occur to control the cracking present.

local stressing was occurring in the brickwork, manifesting itself in the stepped cracking within the mortar to a width of 2mm to the corner element of the gable wall. The cracking evident was believed to have occurred due to normal expansion and contraction due to thermal or moisture movement in the brickwork. The coefficient thermal expansion of brickwork occurs at a rate of 1mm every 1.00m of uninterrupted lengths of masonry. Such cracks tend to open up and move with temperature and moisture changes in the structure. The length of the building found to be approximately 15.00Lm to the side elevation.

Stepped cracking is evident within the mortar joints in isolated areas.

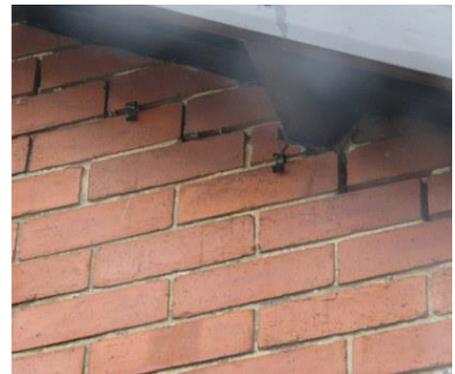
Stepped cracking/missing mortar pointing is evident to the front elevation gable end.

Areas of open/cracked mortar joints were found to be present in a number of areas and due to the issues experience to the rear gable element require repointing to prevent further corrosion of the cavity wall ties to other elevations of the building. A lime mortar should be utilised to allow thermal expansion of the elevations (which were found to be over 15.00Lm in length).

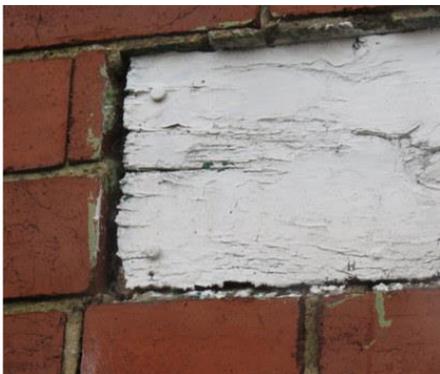
The lintels were found to have received a decorative paint finish which has begun to crack/decay across the provision due to the exposed nature of the building and will require remedial to extend their useful life.

Decay/open mortar joints are evident to the timber lintels in isolated areas.

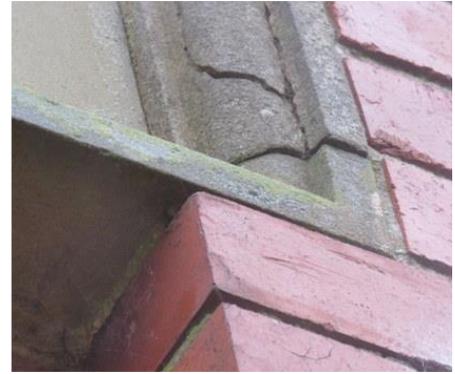
A foundation stone was found to have been constructed with in the front gable element of the building above the level access ramp evident. The mould perimeter section to the stone present was found to be cracked with displacement evident to the lower section. Repair of the provision should be undertaken to prevent loss of the area, which may occur if rainwater entering the crack expands during extreme cold weather (during frost/ice) which will result in the loss of the stone. Due to the height of the provision this may do so onto the ramped area below.

The features were found to be in fair condition and remain in their natural finish, however an element of cracking was present to the foundation stone side moulding with open joints also present.

Date stone to the front elevation at high level is cracked in isolated locations.

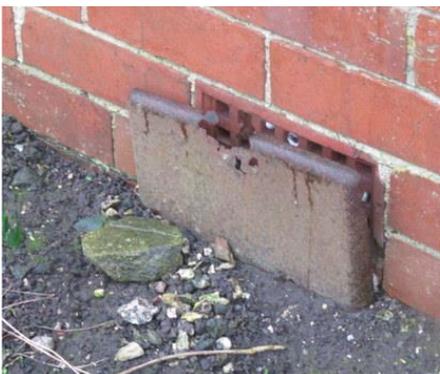
The air bricks were generally found to be located 1N^o course of brickwork above the finished ground level, with the exception to a number to the side/rear gable which are present at or below the earth/soil provision evident. Ideally the ground area abutting the external wall of the property in areas should be reduced in order to prevent rainwater entering the sub floor through the air bricks present, potentially causing decay to the floor structure present.

The air bricks/cast iron grilles were generally found to be in fair condition. Although 1No to the rear is covered over and should be reinstated. An inspection of the ventilation provision should be undertaken, and any debris removed to the face of the air bricks to allow the sub floor to be vented adequately and prevent condensation occurring to the void.

Air bricks are blocked up with debris/foam in isolated areas.

1 No to the gable is covered with a steel plate. This will allow rainwater to enter the floor void and moisture to enter the fabric. The ground area around the provision should be reduced in level to prevent this from occurring.

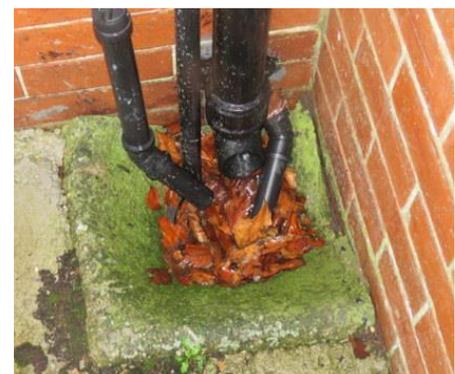
Gullies were found to be blocked at the grates in a number of areas.

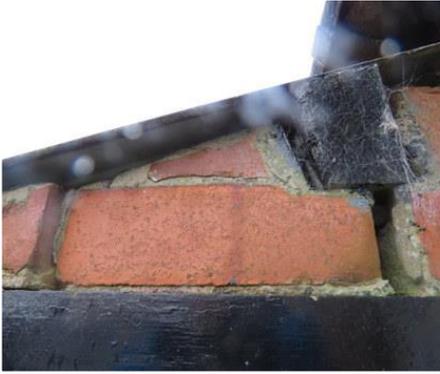
Open mortar joints/loose brickwork is evident to the side elevation half brick thick store room.

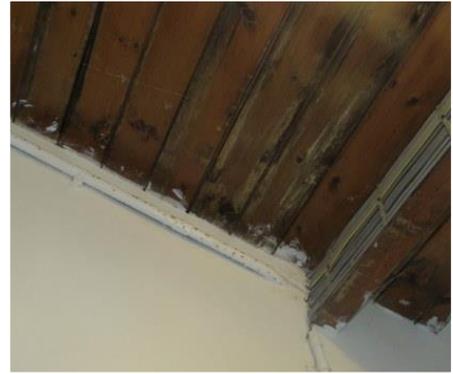
Water stained/decayed timber is evident to the front elevation entrance lobby ceiling.

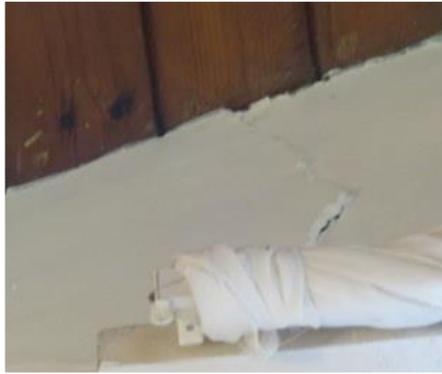
Cracked/loose plaster is evident to the walls in isolated areas.

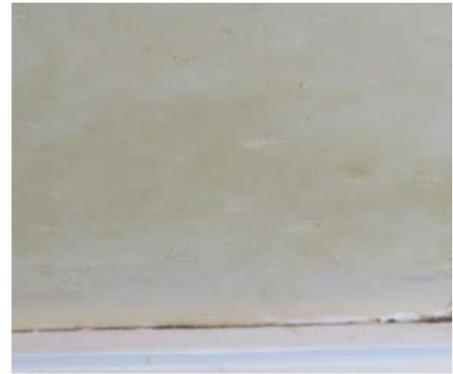
Water ingress/staining is evident to the walls in a number of areas.

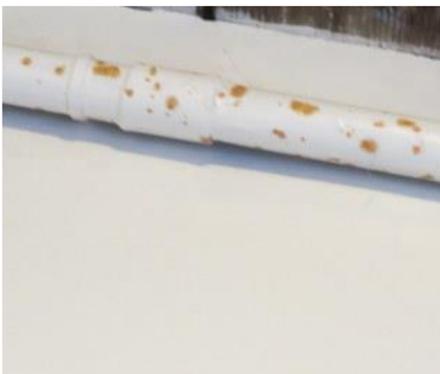
Corrosion staining is evident to the service pipework within the front elevation entrance lobby.

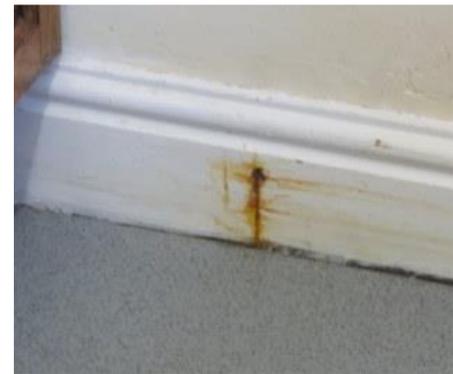
Corrosion staining is evident to a number of fixings within the timber skirtings.

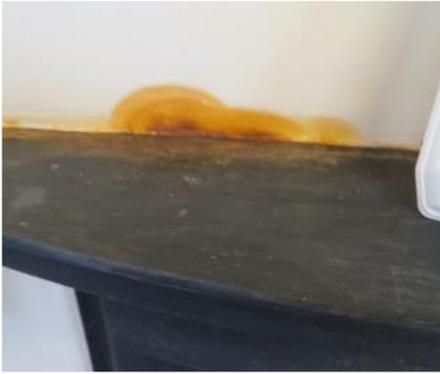
Further corrosion staining is evident surrounding the cast iron fire place located within the side elevation female W/C.

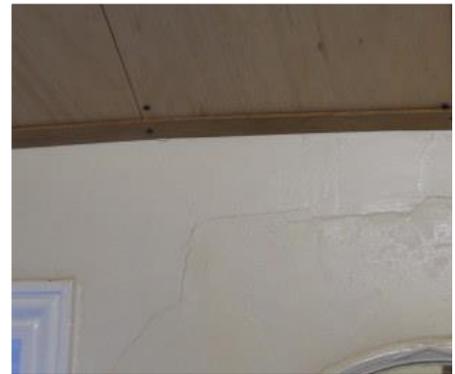
Hairline cracking is evident to the walls in a number of locations.

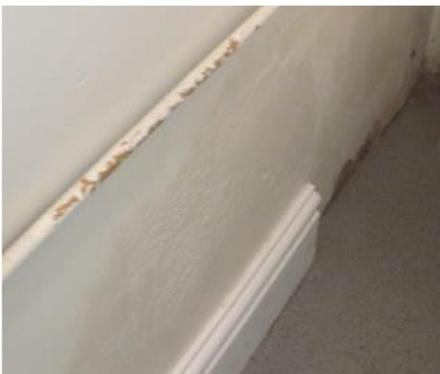
Areas of defective plaster finishes were found to be present extending from above the timber skirting boards up the face of the external/internal masonry walls (up to 500mm (above floor level) to a maximum height in areas). Readings undertaken with an electronic moisture meter of the areas is contained within the main body of the report. Inspection of the walls were no timber skirting detail was present revealed that the plaster finishes had been taken down to the surface of the cast insitu concrete floor structure.

Due to the age of the construction of the structure it is believed that no damp proof membrane exists within the concrete material. Due to the plaster finishes having been taken down to the surface, moisture is being drawn behind the plaster (degrading the wall/timber skirting in areas).

Plaster skim to the walls terminates at ground level in isolated areas (where exposed).

The floor structure was found to be covered with a safety vinyl floor in areas, whilst other areas remain uncovered (or provided with matting). The skirting provision requires removal along with the affected plaster finishes which should be replaced with a renovating plaster (to prevent salts contained within the wall degrading the finish). The floor areas should be refurbished (if not already done so) with a surface damp proof membrane under the vinyl sheet material to prevent long term failure. A coved skirting provision could be utilised within the areas as part of the flooring system in order to assist with maintenance (preventing high level of moisture from mopping of the floor areas on a frequent basis against the timber skirting details).

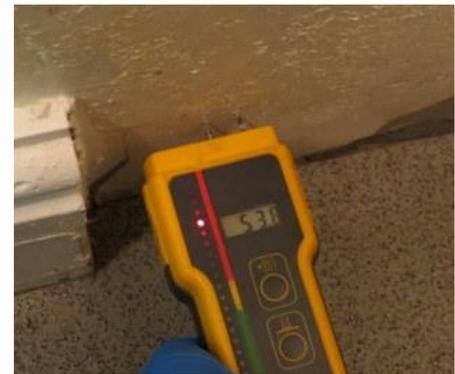
Moisture reading of 53.8% is evident to the side elevation wall within the gentlemen's W/C.

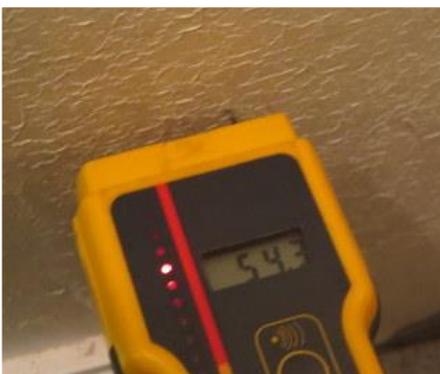
Moisture reading of 54.3% was evident to the side elevation wall within the gentlemen's W/C at a height of 200mm.

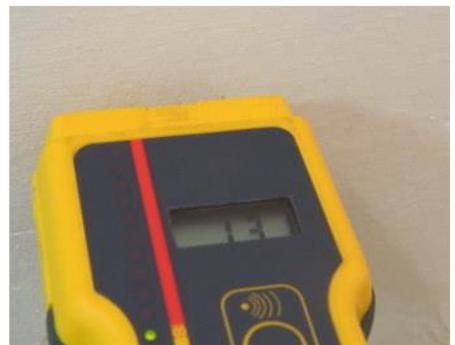
Moisture reading of 13.1% was evident to the side elevation wall within the gentlemen's W/C at a height of 600mm.

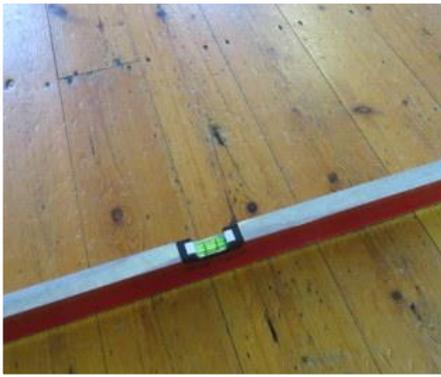
Floor level to the main hall area was found to be level.

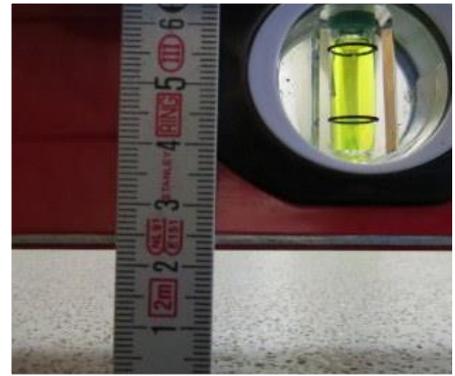
A fall of 25mm is evident to the side elevation within the kitchen.

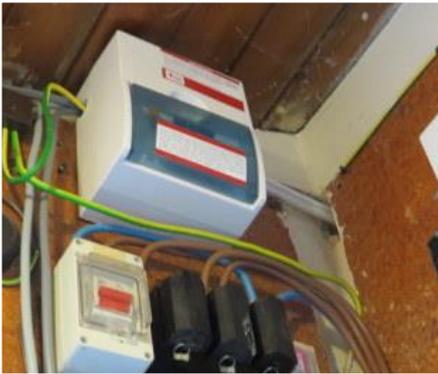
Incoming mains electrics terminates within the front elevation entrance lobby.

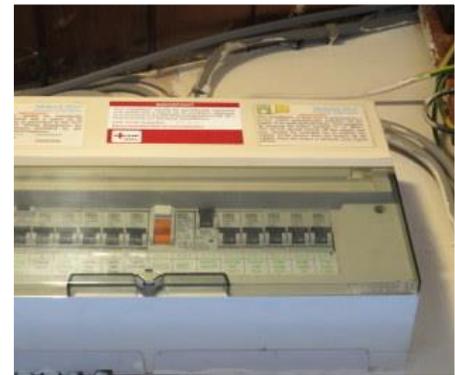
Mains distribution board is located within the front elevation entrance lobby.

- e) It is recommended from our limited inspection that an inspection/test of the electrical installation to the building should be undertaken by a qualified electrician.

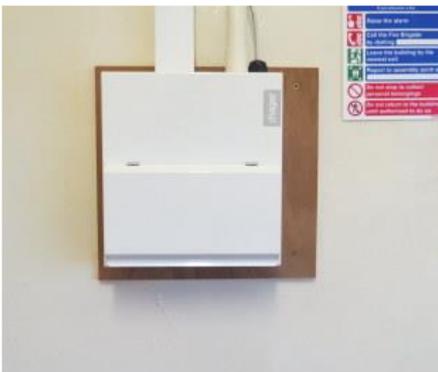
Additional distribution board is located within the side elevation kitchen.

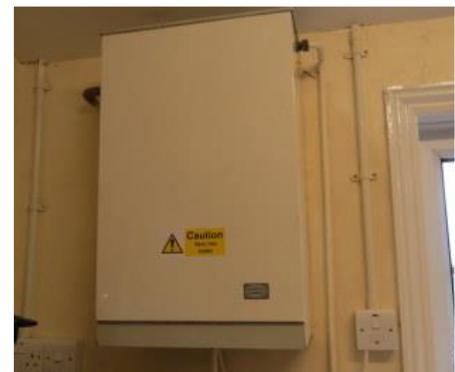
Water heater is located on the side elevation wall within the kitchen.

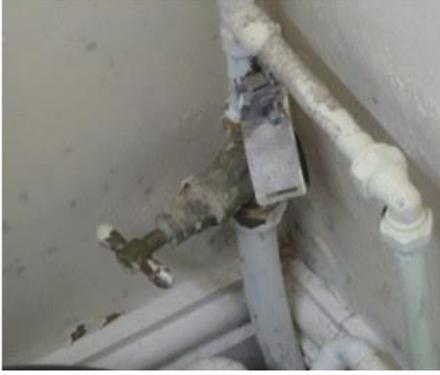
A number of stop taps are located to the to the premises.

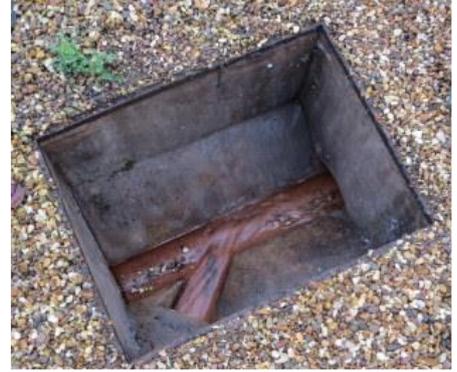
Manhole chamber was running clearly at the time of our inspection.
