# Hall Roof Replacement

April 2021

# Background – Roof Survey December 2021

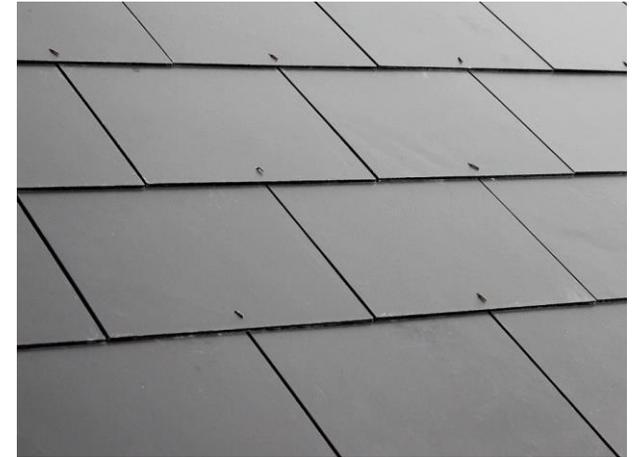
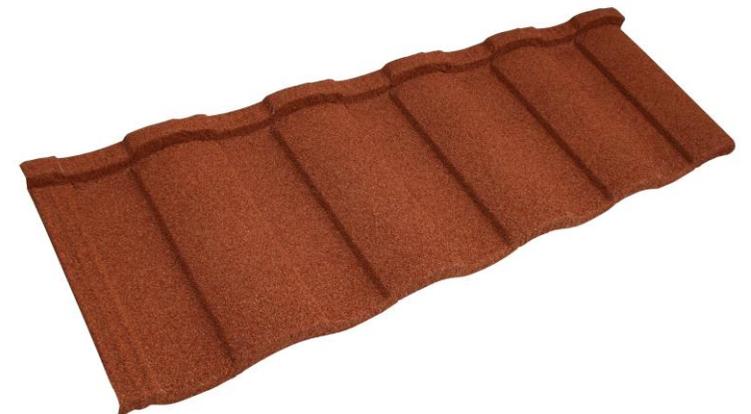
- Colour of the replacement cladding either blue/black; russett; terracotta; stone green; brown or heather?
  - *The present roof, prior to turning grey due to weathering, was once a shade of red.*
  - *Most of the roofs of nearby houses are covered in terracotta coloured, roman clay/cement tiles*
  - *Only one nearby house, Jasmin Cottage has a grey slate roof*
- Type of replacement tiles – Either fibre cement slates or metal profile sheets?
  - *The last would better match the nearby houses with roman tiled roofs*
